Engineering Test and Inspection Sheet

Equipment Burners and	d Windbox Unit # 2 Tes	st/Inspect. DateOct. 27-28, 1991
Inspector <u>Cecil James</u> Responsible Engineer (Initials)		
Item or Test	Observations/Comments	Recommendations

#### INTERMOUNTAIN POWER SERVICE CORPORATION

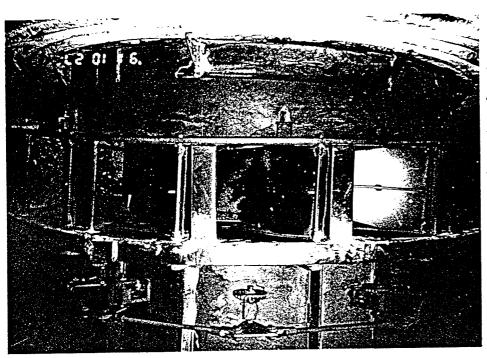
Photo#5: FZ Warped Outer Register.

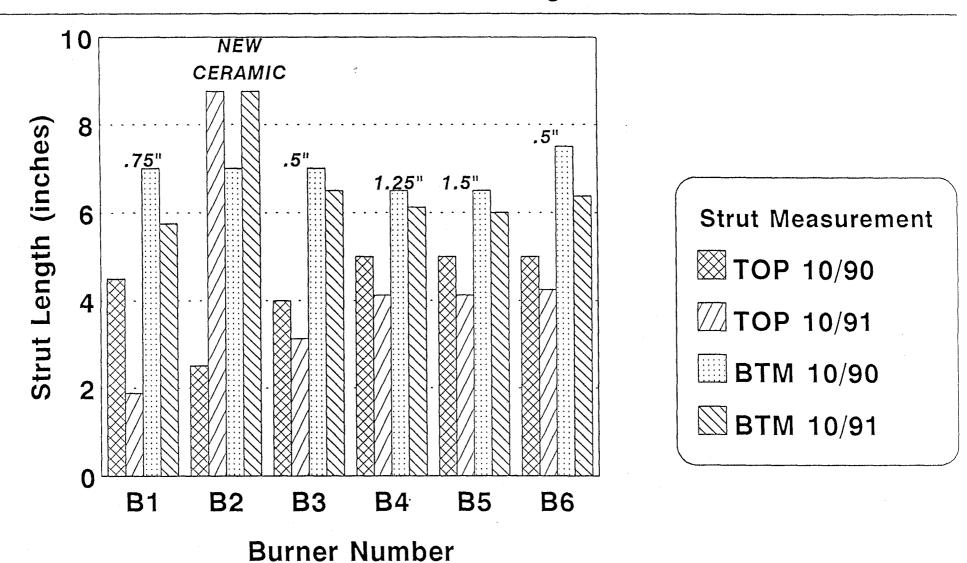
### UNIT 2 BURNER DIFFUSER MEASUREMENTS

Taken October, 1990 and October, 1991 Wear Monitoring

\*\*Numbers above bars indicate size of hole in cone

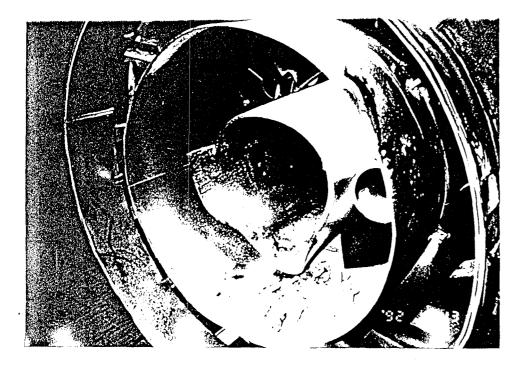
Photo 1: B Row Burner Deformation

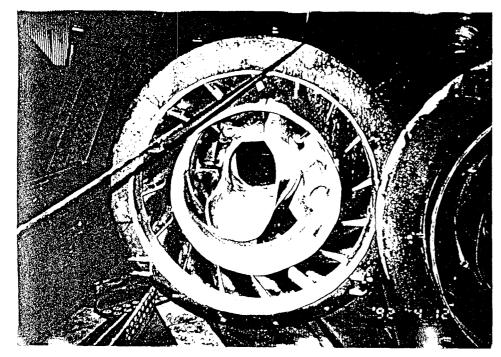
Photo 3: G Row Burner - Severe Nozzle Deformation Photo 4: G Row Burner - Severe Nozzle Deformation

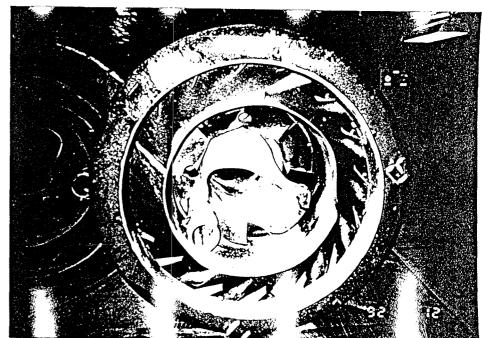
Photo 2: G Row Burner - Severe Nozzle Deformation

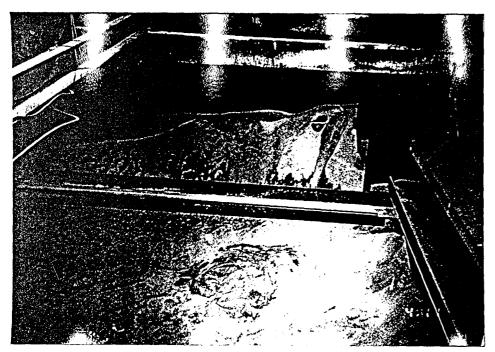
Photo 7: Flyash Accumulation - A Row

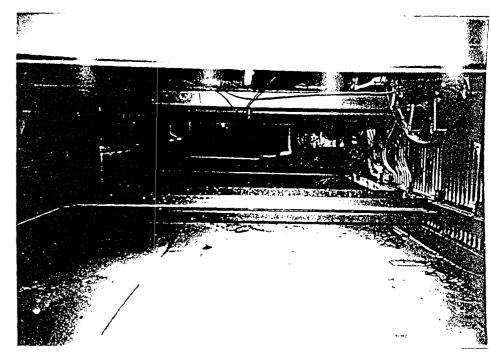
Photo 8: Flyash Accumulation - B Row

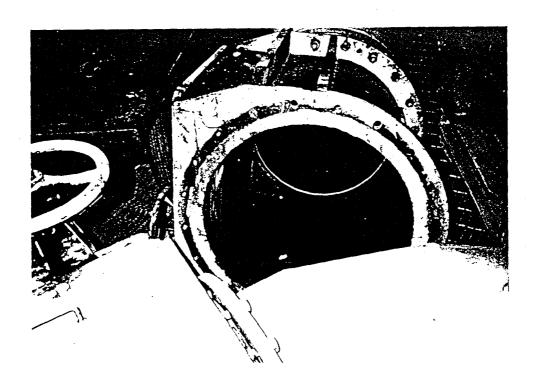
6. A single angle b the outer regist 7. A second observa	the original burners were reliable and required little race from the top of the outer register back plate to ter back plate from deforming backwards. tion port was placed in the outer air zone. The scanne if flame detection could be improved.	he burner casing was installed to prevent	
See photos 1 - 6. Th	removed from the windboxes incurred extensive nozzle da ese burners never gave any indication of nozzle fires we ther burner components show little damage since the las	hile in service and the nozzles show	
Flyash Accumulation in Flyash accumulation i	Windbox n the B, A, G, and H windboxes appear greater than norm	al. See photos 7 and 8.	
the 100 percent open	gates were removed for burner work. Most gates failed position which resulted in gate and gate-seat wear, see seal when the gate was 100 percent closed, see photos 1	photos 9 and 10. The erosion on the gates

Photo 10: Isolation Valve - Gate Open But Still in Coal Path

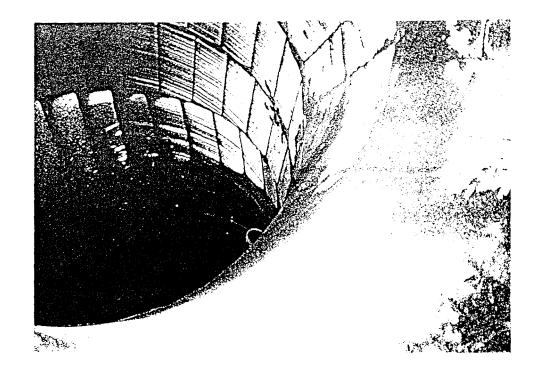
Photo 11: Isolation Valve - Gate Will Not Close Completely

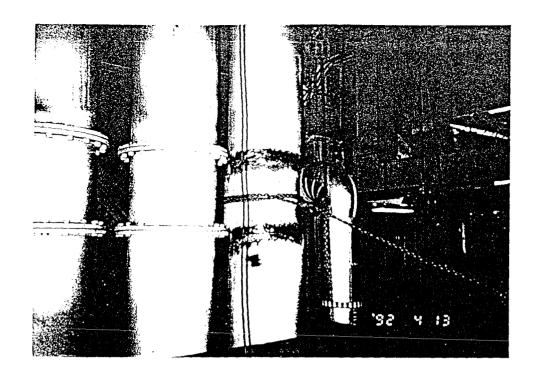
Photo 13: Al Restrictor Installation

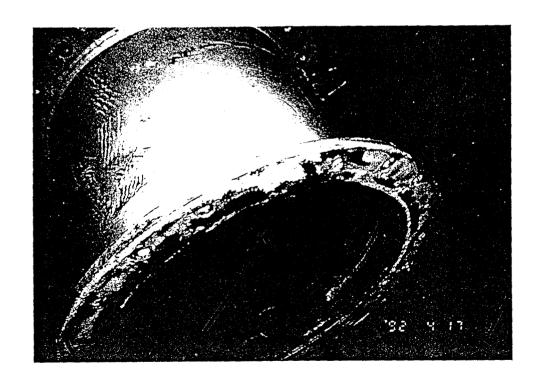
Equipment <u>Burner and</u>	Windbox Unit #	Test/Inspect. Date <u>April 11, 1992</u>	
Inspector <u>Cecil Jame</u>	nspector <u>Cecil James</u> Responsible Engineer (Initials)		
Item or Test	Observations/Comments	Recommendations	
23 restrictors were s photo 14. Since no o re-installed in it's	estrictors were scheduled for modification in an effort elected but only nine were completed. Asbestos gaskets he was prepared for an asbestos abatement procedure, th	were found in some restrictor joints, see	
Burner Line A1 A4 C4 C5 D1 D5 G4 G6 H3	Old Restrictor Size (ID inches) 21 21 21 21 17.5 21 18.38 18.38 21	New Restrictor Size (ID inches) 20 20 19 20 18 20 18 20 18 20	
All further restricto	work will be scheduled to coincide with future pulver	zer maintenance.

Photo 14: Asbestos Gasket - D4 Restrictor
